BATTELLE HALL RENOVATION & EXPANSION COLUMBUS, OHIO

INTRODUCTION

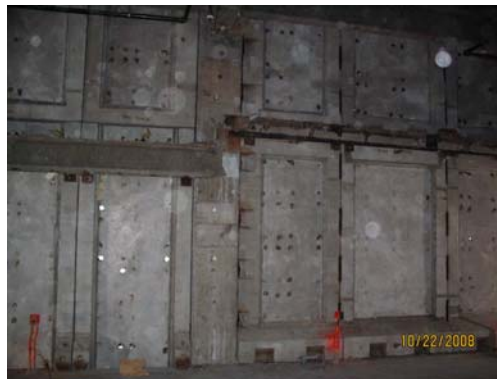
Discovery of welded steel embeds in the existing exterior precast wall.

Early in the project, the team removed the interior finishes to reveal the support details and determine if there were hidden issues that could be resolved without causing a schedule impact. Upon removal of the interior finishes, the team discovered that the precast panels had steel embeds that

were welded together to form the shear reinforcement for the structure in the exterior wall system. Removal of the precast panels would mean the loss of the shear capacity of the structure and had the potential of creating an unstable structural environment.

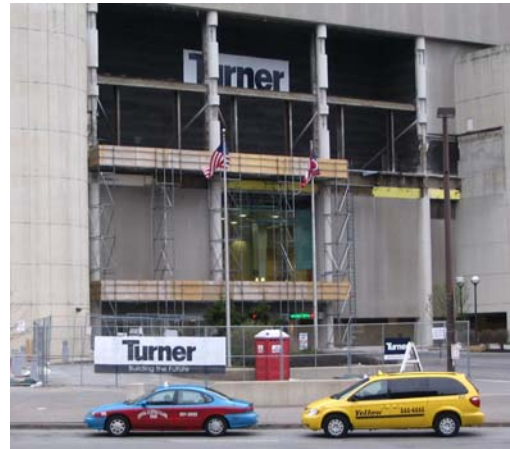
Precision planning and execution led to successful removal of precast panels above the existing glass curtain wall.

Further complicating matters, the removal of the precast paneling was within a half-inch to an existing glass curtain wall below. The 10,000-lb. precast wall panels were bolted to a special custom fabricated clamp, picked up by a crane, one by one, and removed a “caulk joint away” from the existing glass curtain wall below. The slightest deviation could have resulted in the accidental demolition of the existing glass curtain wall. The work had to be performed at night to minimize risk to the

public spaces and to allow for the adjacent parking garage to remain open for scheduled events. Through careful planning and execution, the glass curtain wall below was untouched and the precast panels were removed without incident.

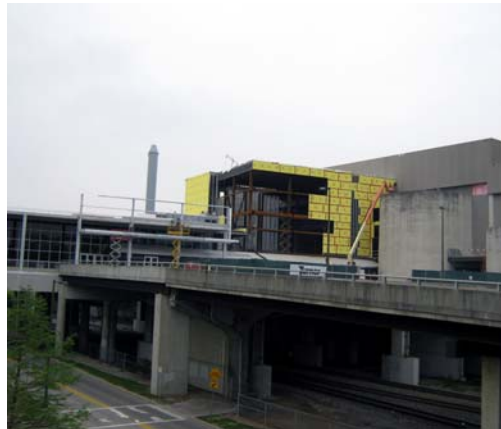
Construction of the new north hall pre-function structure over the existing bridge deck and railroad track.

Another big challenge was the expansion of the north end of the hall. The new structure would be built on an existing bridge deck over an active railroad track. It would span over the bridge deck creating expansion issues and dissimilar movement from motor vehicle traffic

and vibration on the bridge deck. The proximity of the new structure to the existing structures, and the public limited the ability to erect the structure.

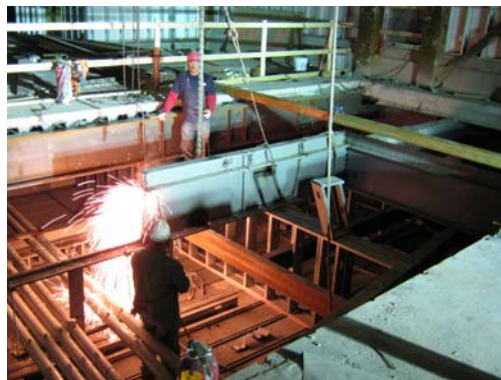
The existing structure was built adjacent to a bridge deck and separated with an expansion joint designed for motor vehicle traffic. The new structure was designed to bear the loads on either side of the expansion joint making erection of the structural members a challenging endeavor. The structural members that were to be installed south of the expansion were supported from the existing structural steel members with moment connections. The structural members north of the expansion were erected on the bridge deck and connected to the southern structure with slip connections. In addition, four escalators were installed across the expansion joint using similar structural techniques.

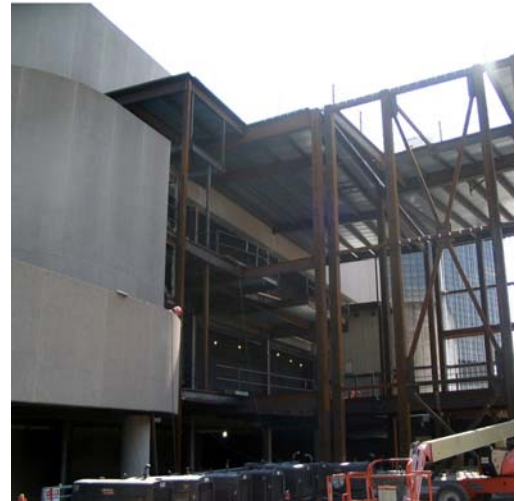
Double columns signify the separation between the bridge deck construction and expansion of the existing building structure.

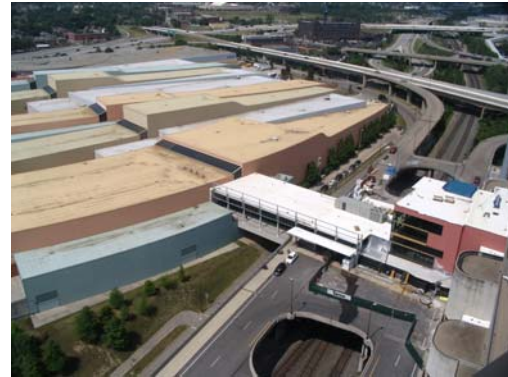
Designers replicate convention center roof lines for lighting design in the new Battelle Grand ballroom.

The design concept was created to match the roof lines of the convention center. Looking at an aerial view of the convention center's exterior, one notices a number of curved lines meant to resemble the number of trains and train tracks that once traveled

through the area, even below the very ground upon which the convention center sits. For the ceiling of the ballroom, the vision was to reproduce this look in a modern and aesthetically-pleasing appearance, paying homage to the area's historic past.

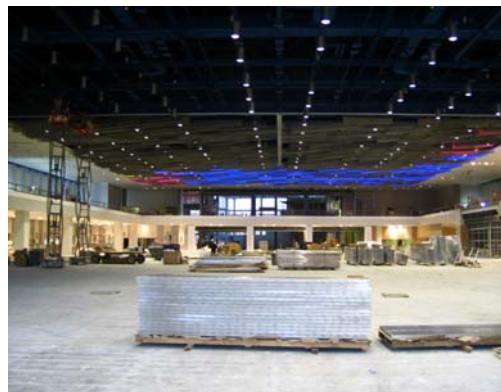
Pattern drawn on ballroom floor provided for accurate installation of the 1,250 lighted ceiling fins.

The installation of the fins was a challenge in keeping the different configurations organized during the planning phase. The fins were in three configurations: C-shape, closed-end and a fin that is filled with LED-lights. To ensure that all fins were placed and installed

properly, a pattern was drawn on the concrete floor of where each fin was to go, 35 feet overhead.

Using the pattern as a reference, a laser line was shot to the ceiling so the hanging hooks could be accurately installed – with hook configurations specific to the different types of fins.

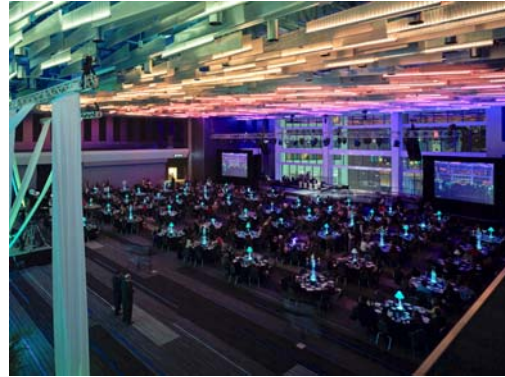
The artistic “Ceiling of Fins” lighting display offers guests a unique and memorable event experience.

In the end, 1,250 total ceiling fins were installed, with 350 of them having the LED-stripe lighting. At the touch of a button, the room can glow in solid reds, greens, blues or change to a rainbow appearance. Guests who rent the room can select the lighting appearance of the fins.

Controlled by an intricate touch-screen panel, the system is sophisticated enough to

act as a large television screen to show video or have a company logo floating across the ceiling during a business gathering.

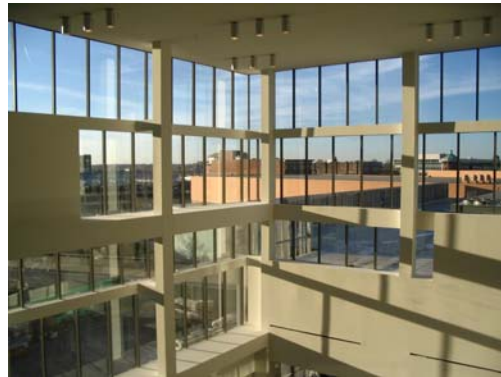
New two-story window provides natural lighting and view of Arena District.

“The most difficult structural challenge was the addition of a large new 3,500-square-foot window wall on the south end of the ballroom,” said John Lyons, principal structural engineer. “This allows the occupants to enjoy a view of the city skyline – it contributes greatly to the sense of openness experienced by the ballroom guests.”

“Key to the repositioning of this space was the two-story window wall that was built overlooking the Arena District. These structural changes were also among the most challenging components of the project.
